INDOOR AIR QUALITY ASSESSMENT

**M. Norcross Stratton Elementary School
180 Mountain Avenue
Arlington, MA 02474**

Prepared by:
Massachusetts Department of Public Health
Center for Environmental Health
Emergency Response/Indoor Air Quality Program
July 2005

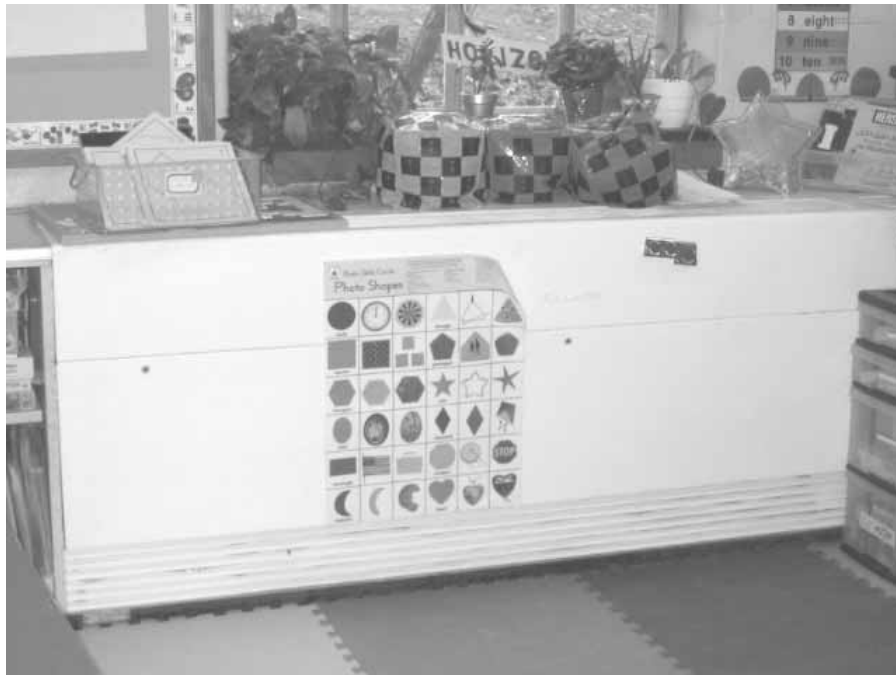
Picture 1

It can be seen from Table 1 that carbon dioxide levels were elevated above 800 parts per million (ppm) in 26 of 37 areas surveyed, indicating inadequate air exchange in the majority of areas surveyed. Fresh air in classrooms is supplied by unit ventilator (univent) systems (Picture

Classroom univent, note items on top of unit

2. Examine each univent for function. Survey classrooms for univent function to ascertain if an adequate air supply exists for each room. Consider consulting a heating, ventilation and air conditioning (HVAC) engineer concerning the calibration of univent fresh air control dampers.

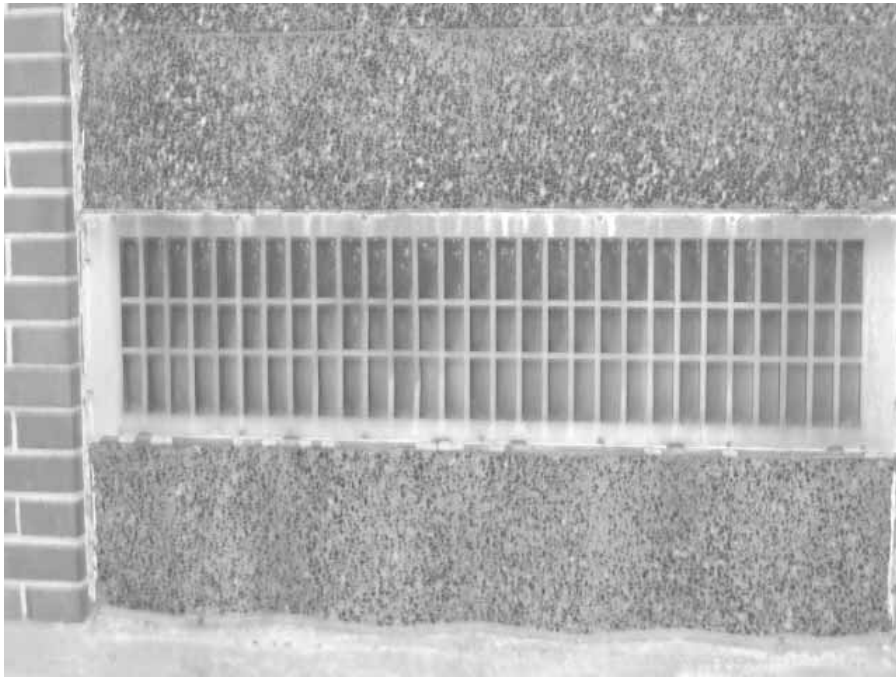
Picture 2

1). A univent draws air from outdoors through a fresh air intake located on the exterior wall of the building (Picture 2) and returns air through an air intake located at the base of the unit (Figure 1). Fresh and return air are mixed, filtered, heated and/or cooled and provided to classrooms through a diffuser located on the top of the unit. Obstructions to airflow, such as furniture located in front of and/or materials stored on univents, were observed in many areas (Pictures 1 and 3). Moreover, many univents were not operating at the time of the assessment. In order for univents to provide fresh air as designed, intakes and returns must remain free of obstructions and importantly, these units must remain activated and allowed to operate while rooms are occupied.

Univent fresh air intake

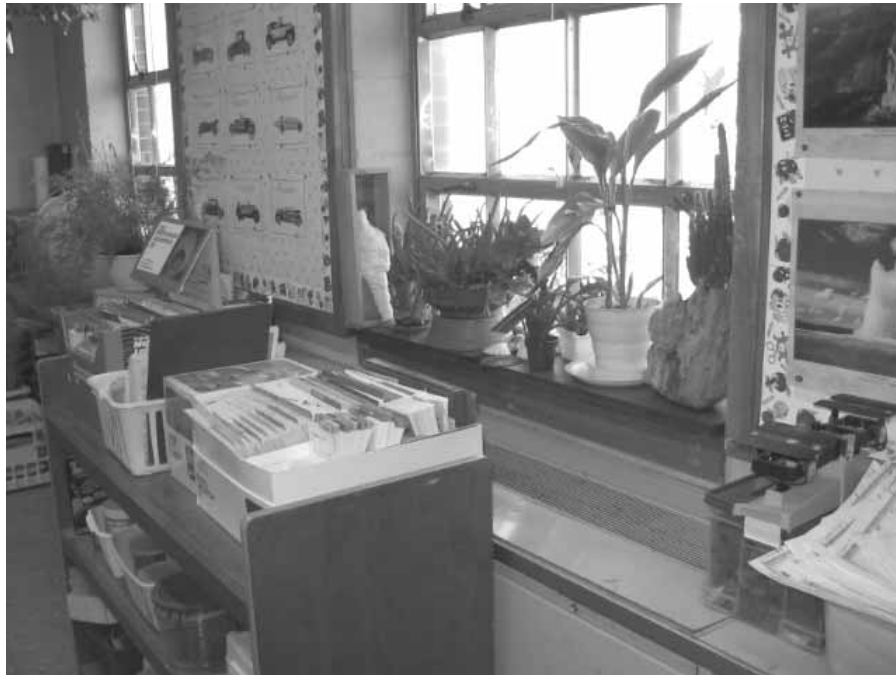
Picture 3

Furniture placed in front of univent

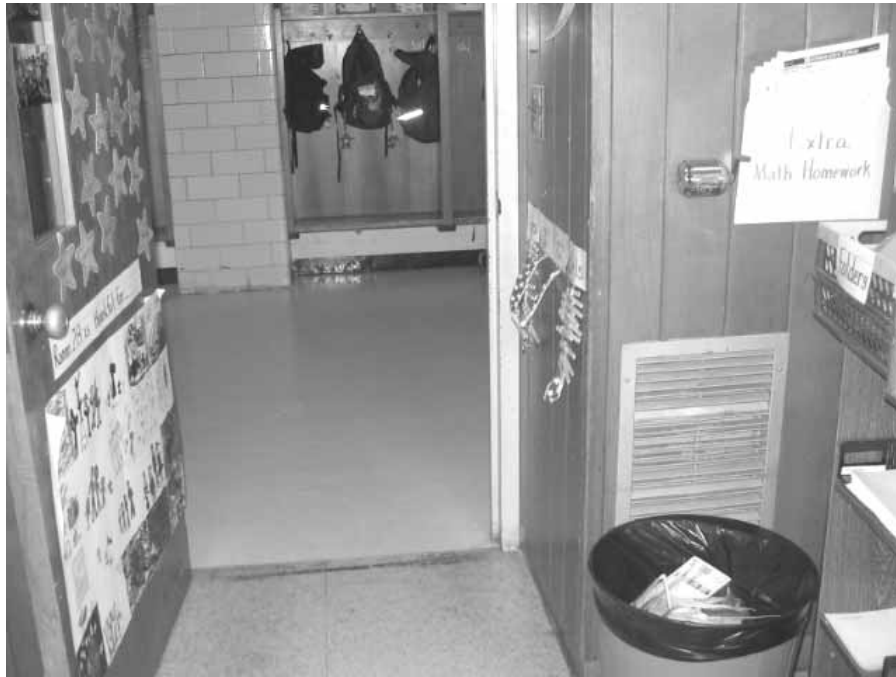
Picture 4

Mechanical exhaust ventilation in classrooms is provided by wall-mounted exhaust vents (Picture 4) ducted to rooftop exhaust fans (Picture 5). APS staff indicated one exhaust fan motor was not operating at the time of the assessment. As a result, a number of exhaust vents were off at the time of the assessment. It is important to note that the location of some exhaust vents can limit exhaust efficiency. In some classrooms, exhaust vents are located behind hallway doors (Picture 6). When classroom doors are open, exhaust vents are blocked. In addition, other blockages to exhaust (i.e., furniture or items placed in front) were noted (Picture 7). The effectiveness of exhaust vents to remove common environmental pollutants from classrooms becomes reduced when the vent is blocked. As with univents, exhaust vents must remain free of obstructions in order to operate as designed.

Classroom wall exhaust vent

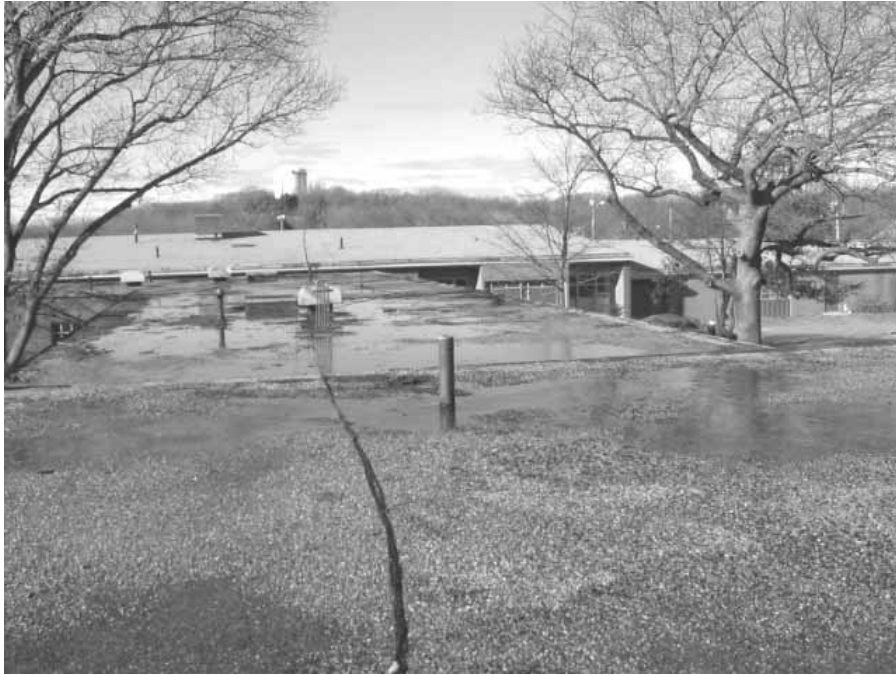
Picture 5

Rooftop exhaust fan

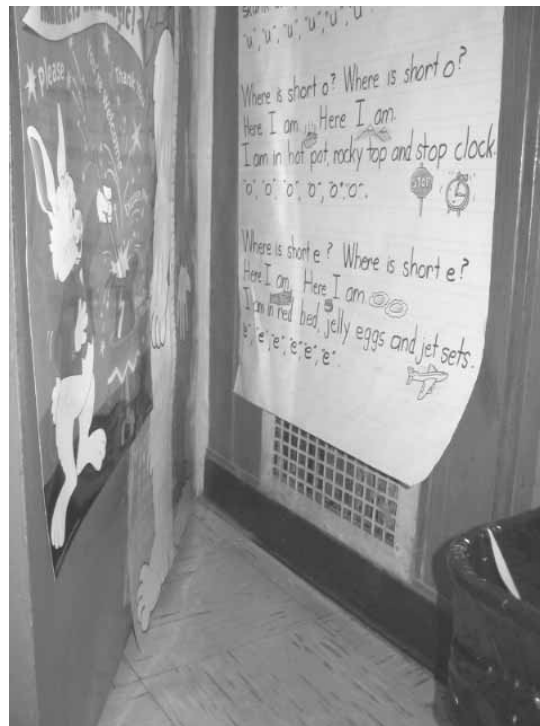
Picture 6

Exhaust vent located behind door

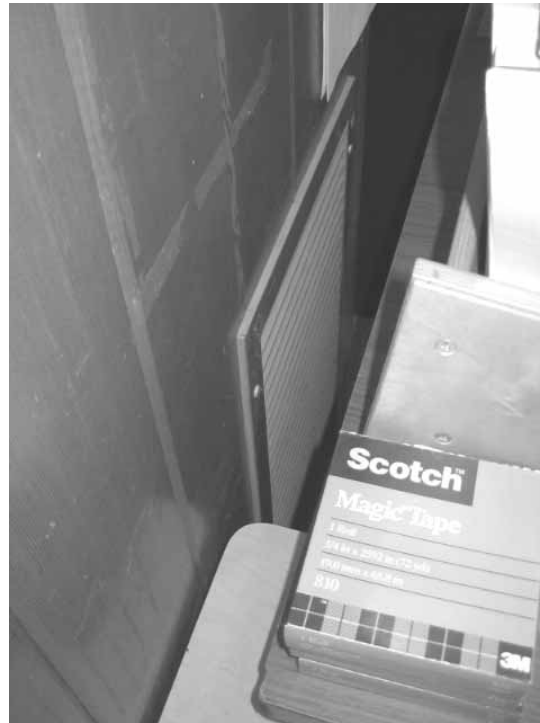
Picture 7

Furniture placed in front of wall exhaust

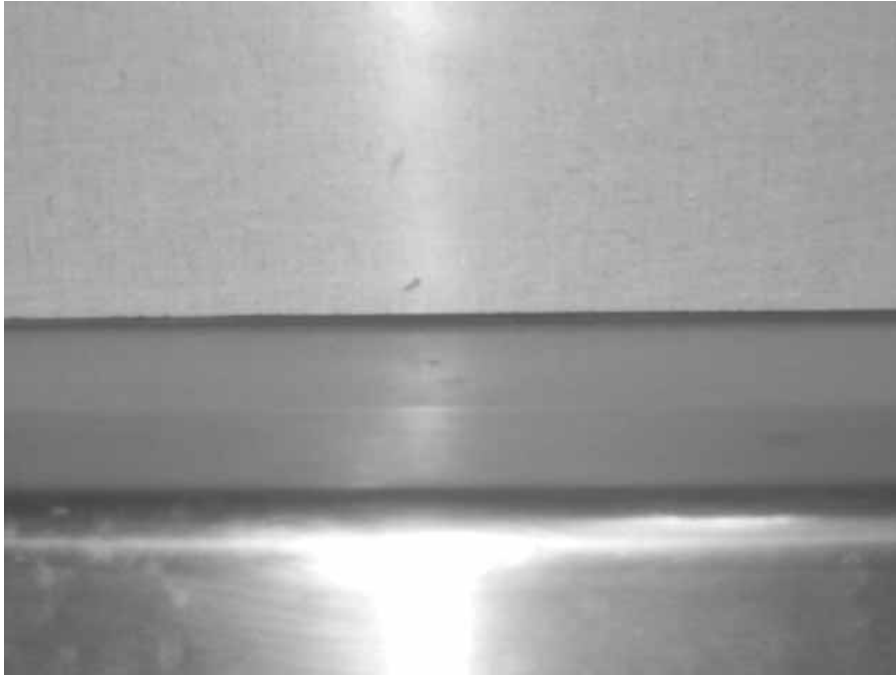
Picture 8

between the sink countertop and backsplash were seen in several areas (Picture 8). Improper drainage or sink overflow can lead to water penetration into the countertop, cabinet interior and areas behind cabinets. If these materials become wet repeatedly they can provide a medium for mold growth. The US Environmental Protection Agency (US EPA) and the American Conference of Governmental Industrial Hygienists (ACGIH) recommend that porous materials be dried with fans and heating within 24 to 48 hours of becoming wet (US EPA, 2001; ACGIH, 1989). If porous materials are not dried within this time frame, mold growth may occur.

Breach between sink countertop and backsplash

7. Seal breaches between sink countertops and backsplashes with an appropriate sealant to prevent water damage and potential mold growth.
8. Move plants away from univents in classrooms. Ensure all plants are equipped with drip pans. Examine drip pans for mold growth and disinfect areas of water leaks with an appropriate antimicrobial where necessary.

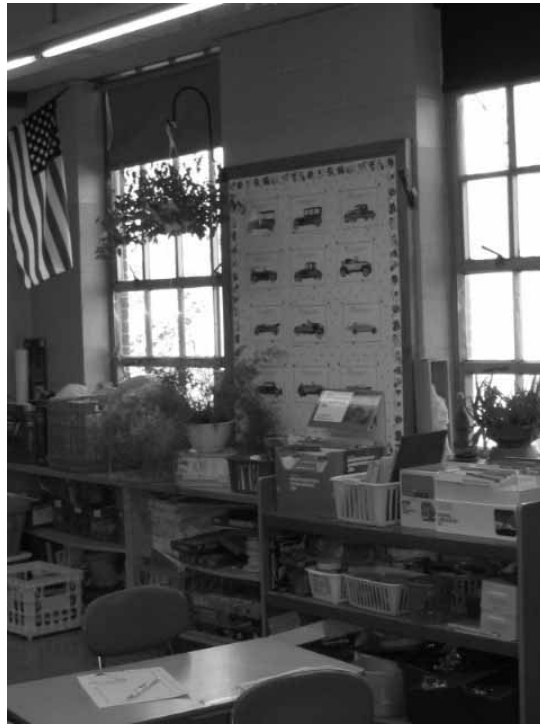
Picture 9

Plants were noted in several areas (Picture 9). Plants, soil and drip pans can serve as sources of mold growth, and thus should be properly maintained. Plants should have drip pans to prevent wetting and subsequent mold colonization of window frames. Plants should also be located away from univents and ventilation sources to prevent aerosolization of dirt, pollen or mold.

Plants in classroom

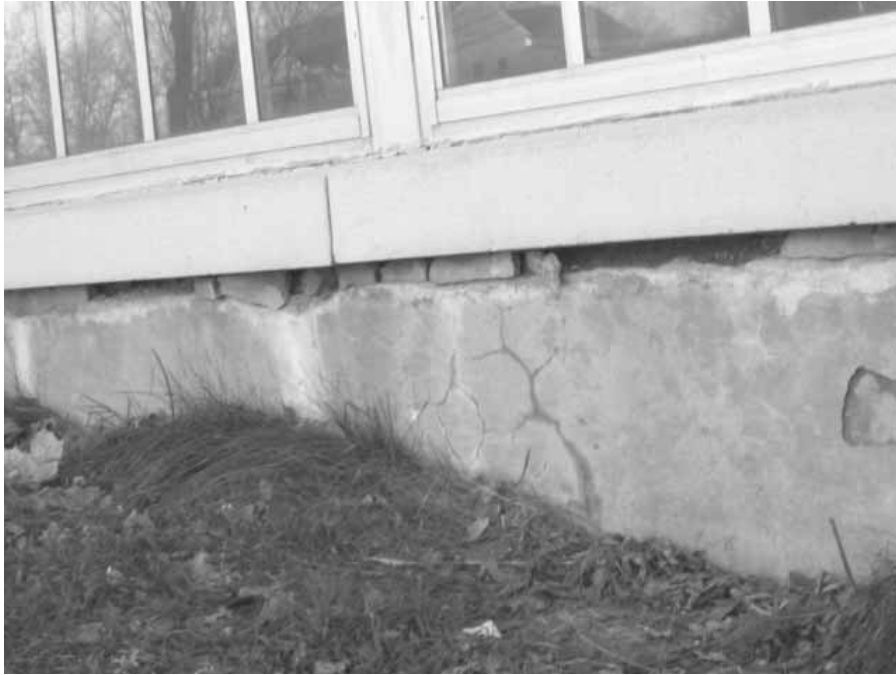
Picture 10

During an inspection of the building exterior, MDPH staff observed damage to the foundation (Pictures 10 and 11). Breaches, cracks and holes in the foundation can serve as points for water entry into the building. Continued freezing and thawing of water during cooler months will serve only to further damage the foundation. In addition, breaches can serve as points of entry or shelter for pests.

Damage to foundation

9. Repair damage to building foundation. Consider contacting a building envelope specialist for an evaluation of the building exterior.
10. Maintain roof drains to ensure proper drainage.

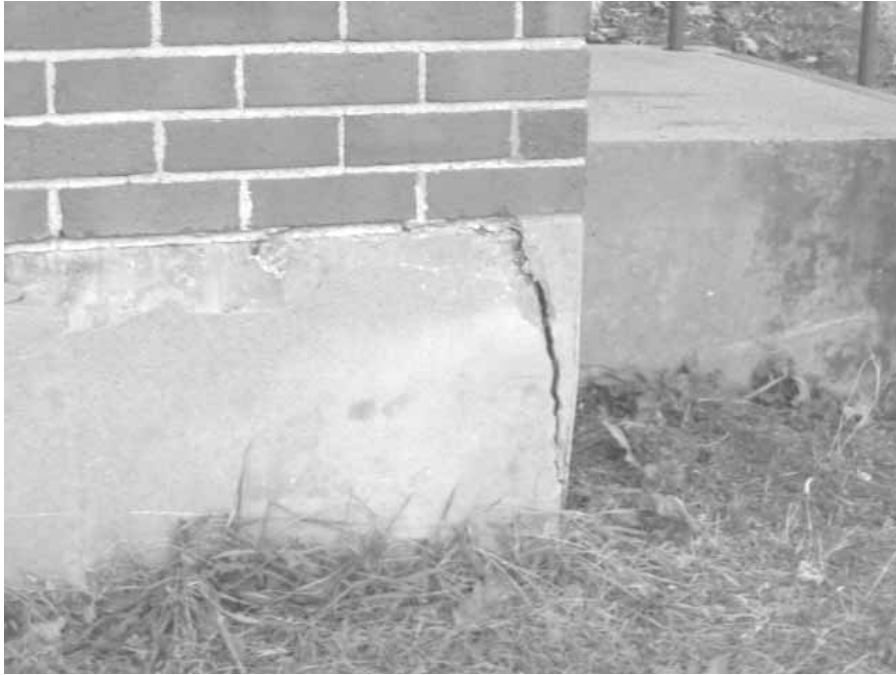
Picture 11

Crack in foundation

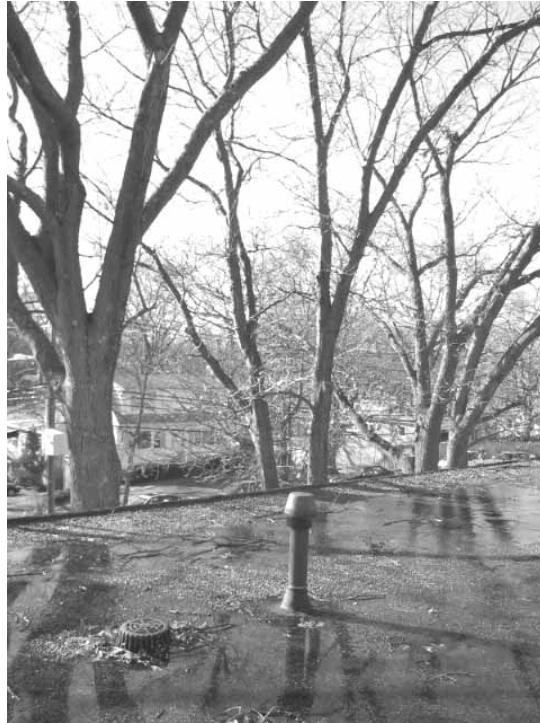
Picture 12

Lastly, pooling water was observed on the roof as a result of poor drainage (Picture 12). In one case, a roof drain was observed to be clogged with leaves and other debris (Picture 13). Roof drains should be cleared of debris to prevent water pooling on the roof. Over time, pooling water can seep into the building, causing damage to ceiling tiles and other building materials. Freezing and thawing of pooled water can eventually degrade the integrity of the rubber

membrane roof, causing cracks to form. These breaches can allow water to penetrate the building.

Water pooling on rooftop

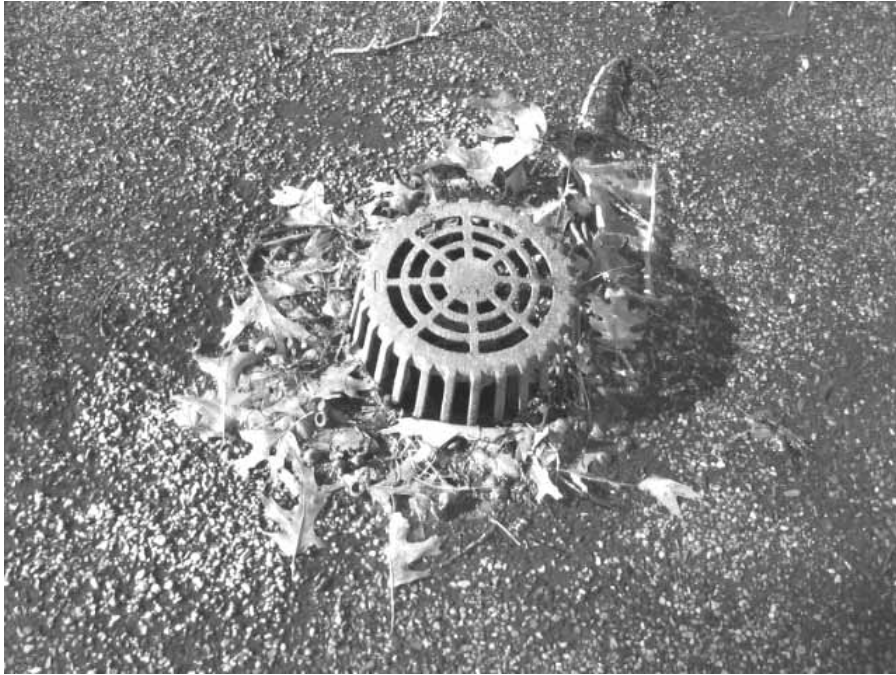
Picture 13

Clogged roof drain

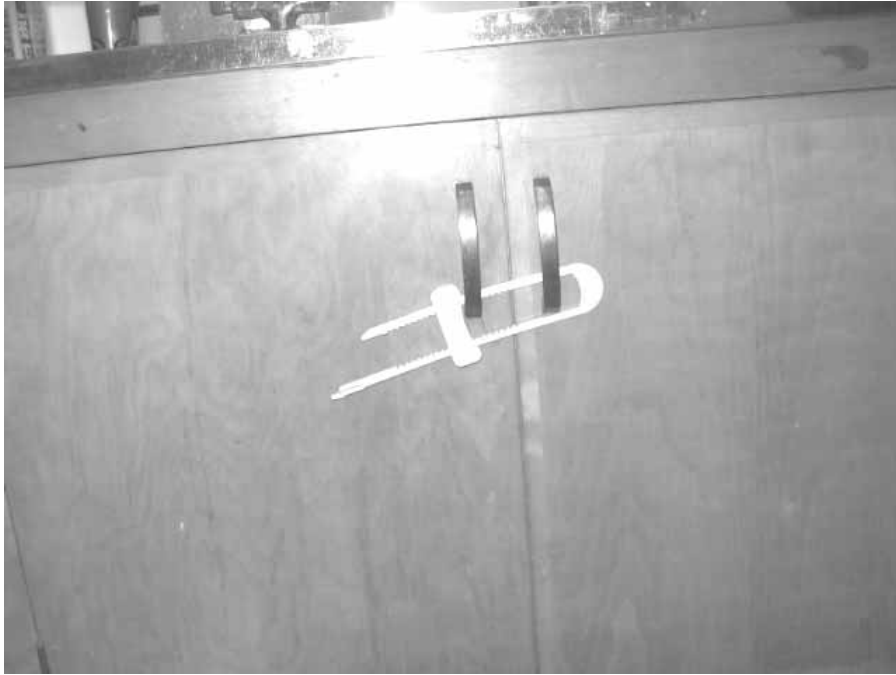
Picture 14

Cleaning products were found on countertops and beneath sinks in a number of classrooms. In some cases, cleaning products were placed in cabinets with childproof locks (Picture 14). Consideration should be given to adopting this practice throughout the school as a measure to prevent child access to cleaning agents. Cleaning products contain VOCs and other chemicals, which can be irritating to the eyes, nose and throat and should be stored properly and kept out of reach of students.

Use of childproof locks on cabinets

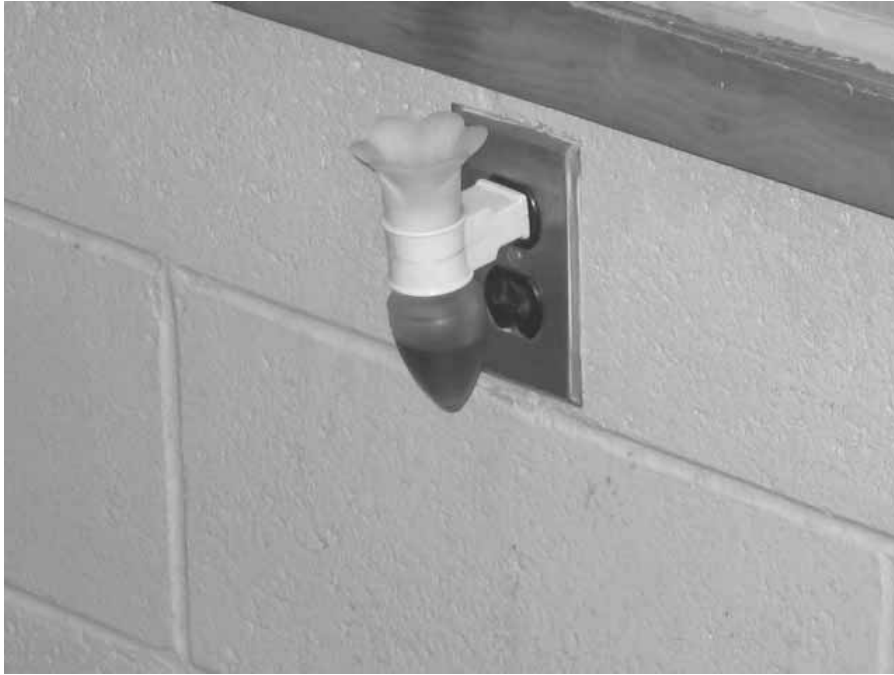
Picture 15

A strong fragrance was detected in a number of classrooms. The source of these odors was plug-in air fresheners (Picture 15). Air fresheners contain chemicals that can be irritating to the eyes, nose and throat of sensitive individuals. Furthermore, air fresheners do not remove materials causing odors, but rather mask odors that may be present in the area.

Plug-in air deodorizer

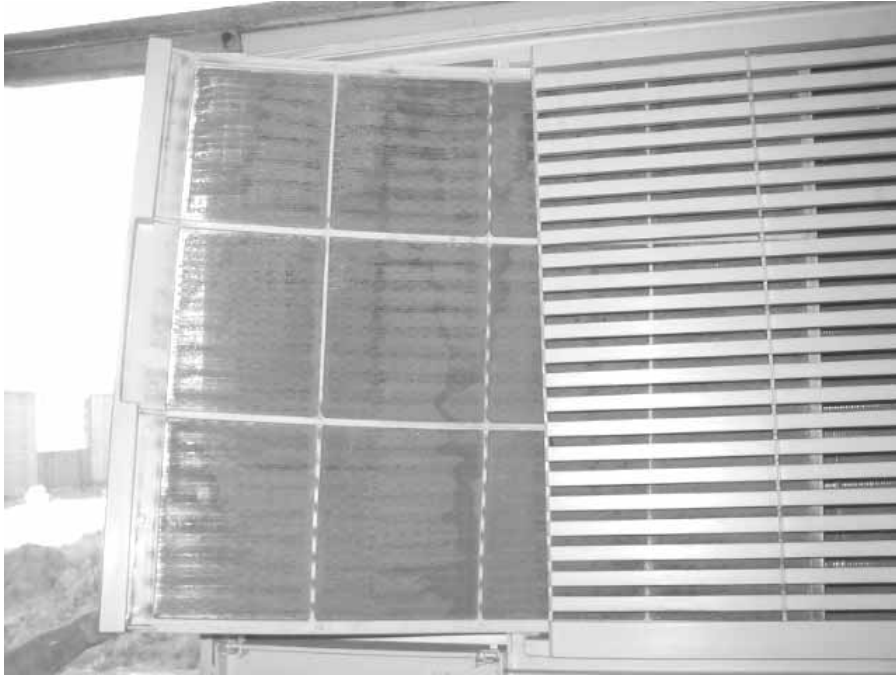
Picture 16

Several areas contained window-mounted air conditioners (ACs). These type of ACs are normally equipped with filters. MDPH staff observed dust occluded on AC filters (Picture 16), which should be cleaned or changed as per manufacturer's instructions to avoid the build up and re-aerosolization of dirt, dust and particulate matter. Univents are also normally equipped with filters that strain particulates from airflow. The univent filters at the SES provide minimal filtration of respirable dusts. In addition, some univents did not have appropriately sized filters, which allows for air to by-pass the filter (Picture 17). In order to decrease aerosolized particulates, disposable filters with an increased dust spot efficiency can be installed. The dust spot efficiency is the ability of a filter to remove particulates of a certain diameter from air passing through the filter. Filters that have been determined by the American Society of Heating, Refrigeration and Air-Conditioning Engineers (ASHRAE) to meet its standard for a dust spot efficiency of a minimum of 40 percent would be sufficient to reduce airborne particulates (Thornburg, 2000; MEHRC, 1997; ASHRAE, 1992). Note that increased filtration can reduce airflow as a result of increased resistance, a condition known as pressure drop. Prior to any increase of filtration, univents should be evaluated by a ventilation engineer to ascertain whether units can maintain function with more efficient filters.

Dust occluded window-mounted air conditioner filter

15. Clean filters for window-mounted air conditions as per manufacturer's recommendation.
16. Relocate or consider reducing the amount of materials stored in classrooms to allow for more thorough cleaning. Clean items regularly with a wet cloth or sponge to prevent excessive dust build-up.

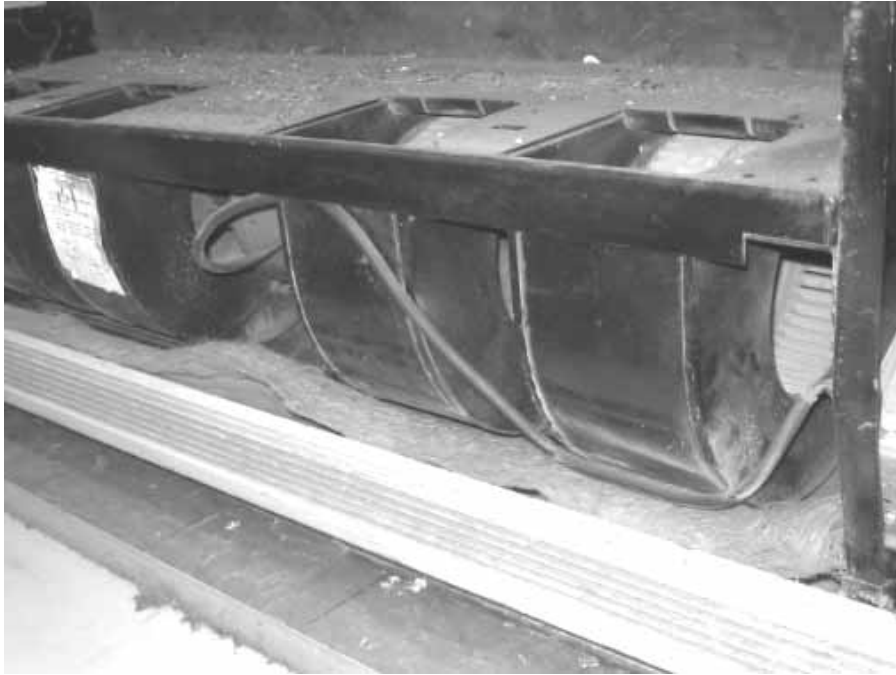
Picture 17

Poorly sized univalent filter that is missing case

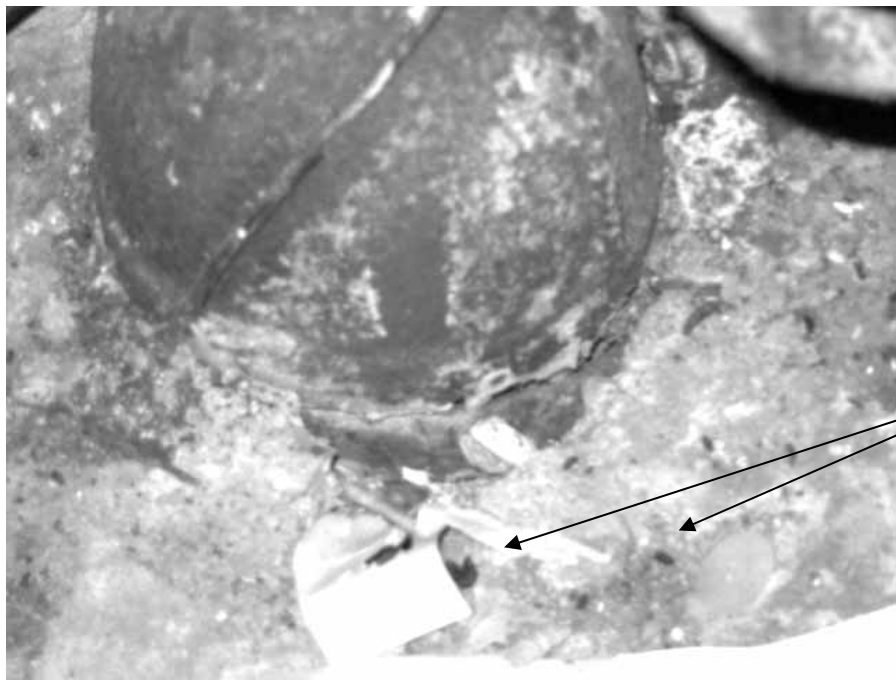
Picture 18

Rodent droppings were noted in the air-handling cabinet of a univent (Picture 18). Pest attractants were identified within the building. Food-based projects and re-use of food containers were observed. Proper food storage is an integral component in maintaining indoor air quality. Food should be properly stored and clearly labeled. Reuse of food containers is not recommended since food residue adhering to the surface may serve to attract pests.

Rodent infestation can result in indoor air quality related symptoms due to materials in rodent wastes. Mouse urine contains a protein that is a known sensitizer (US EPA, 1992). A sensitizer is a material that can produce symptoms (e.g., running nose or skin rashes) in sensitive individuals. Since particulate materials can be drawn into an air stream, univents with filters that provide minimal respirable dust filtration can serve to distribute these materials. It is important that proper filters be installed in univents to reduce this potential problem.

Rodent
droppings

Rodent droppings in air-handling cabinet of univent

A three-step approach is necessary to eliminate rodent infestation:

- removal of the rodents;
- cleaning of waste products from the interior of the building; and
- reduction/elimination of pathways/food sources that are attracting rodents.

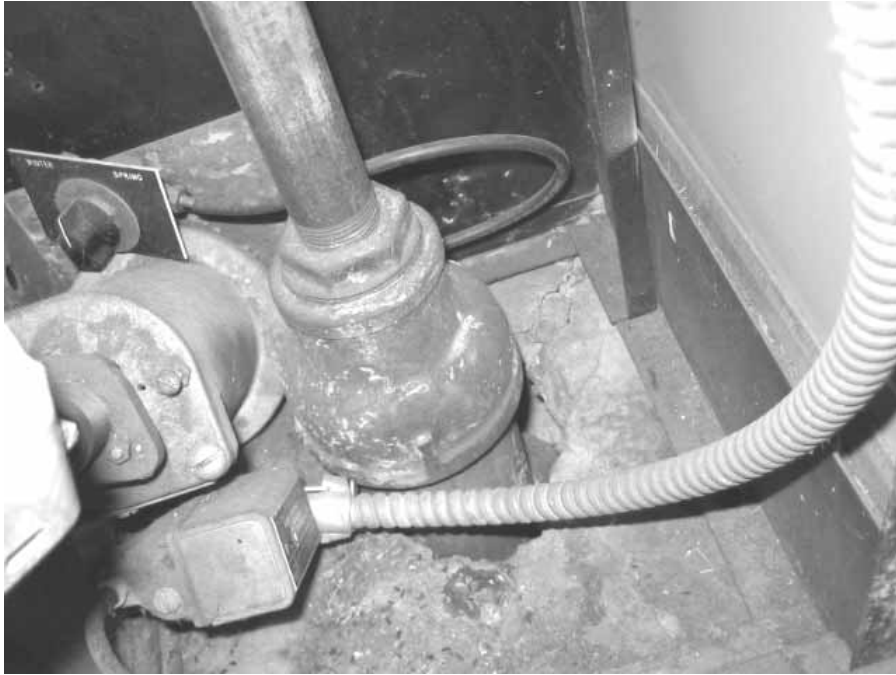
Picture 19

Breaches were also observed around pipes in univent air-handling cabinets (Picture 19). Spaces of this nature can result in the univent drawing air, odors and debris from the wall cavity or crawlspace. Materials drawn from the crawlspace or wall cavity may bypass the univent filter, providing a means for distributing these materials from an unoccupied to an occupied area.

Breach around pipe in univent air-handling cabinet

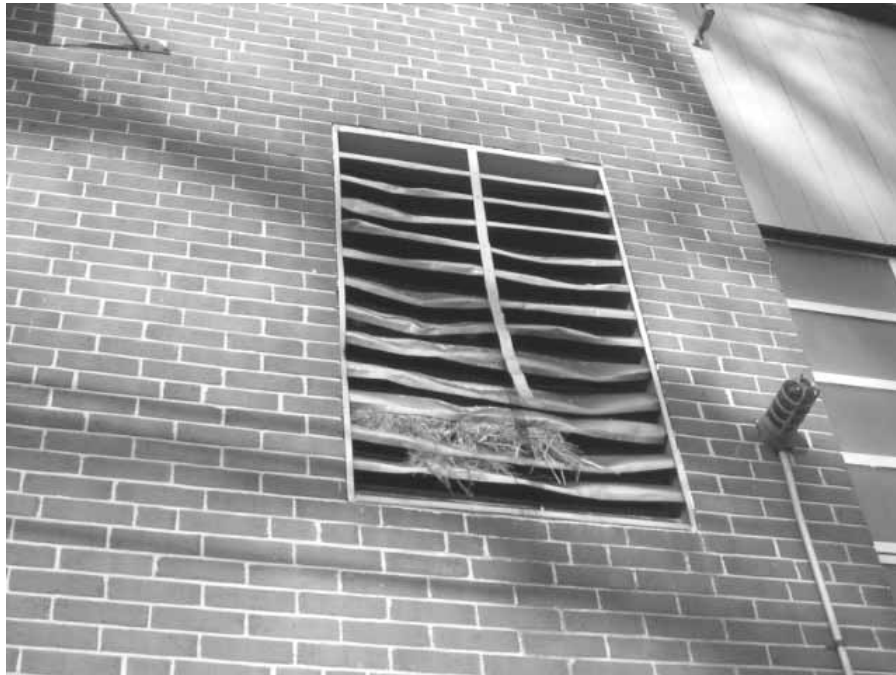
Picture 20

Signs of bird roosting and nesting materials were observed in a school bell and exhaust vent, near openable windows and univent fresh air intakes (Picture 20). MDPH staff recommended that the nest be removed to prevent entrainment of bird wastes. Birds can be a source of disease, and bird wastes and feathers can contain mold and bacteria. No obvious signs of bird roosting *inside* the building were noted by MDPH staff nor were such signs reported by occupants.

Bird nesting material in exhaust

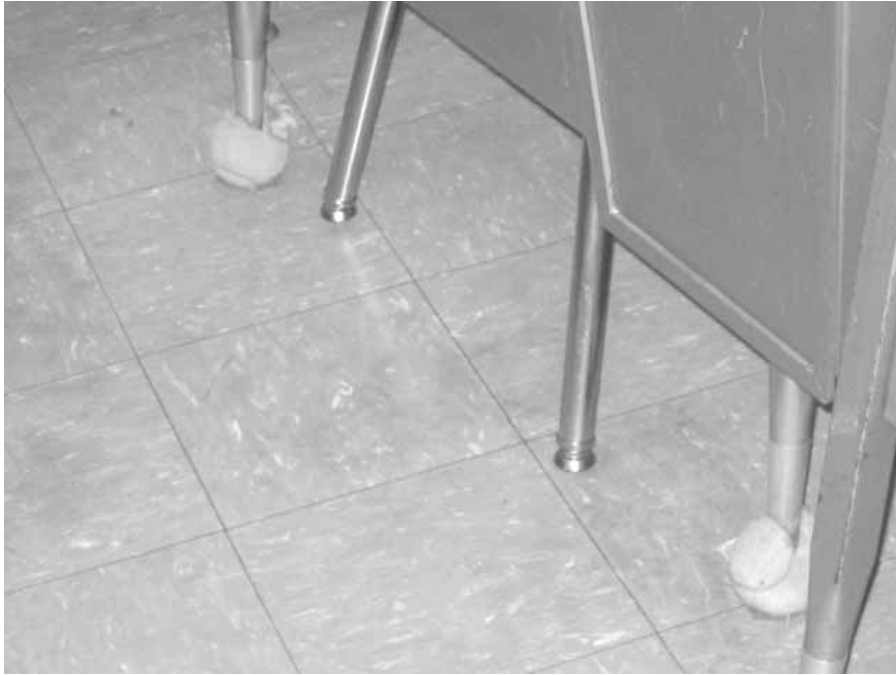
Picture 21

In an effort to reduce noise from sliding chairs, tennis balls had been sliced open and placed on chair legs (Picture 21). Tennis balls are made of a number of materials that are a source of respiratory irritants. Constant wearing of tennis balls can produce fibers and off-gas VOCs. Tennis balls are made with a natural rubber latex bladder, which becomes abraded when used as a chair leg pad. Use of tennis balls in this manner may introduce latex dust into the

school environment. Some individuals are highly allergic to latex (e.g., spina bifida patients) (SBAA, 2001). It is recommended that the use of materials containing latex be limited in buildings to reduce the likelihood of symptoms in sensitive individuals (NIOSH, 1997). A question and answer sheet concerning latex allergy is attached as Appendix B (NIOSH, 1998). Consider using alternative “glides” on chair legs (Picture 22).

Tennis balls on chair leg

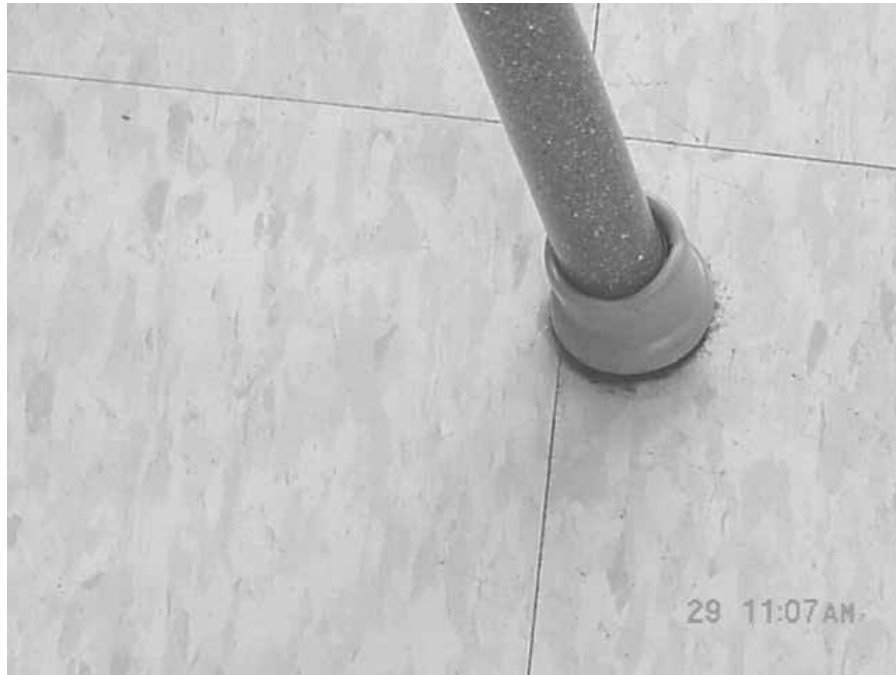
Picture 22

“Glides” on Bottom of Chair Legs
